**Flood Control Project Maintenance
Levee Inspections**

Maintenance Issue Types Only, Levee Inspection Report By Mile - Spring 2020

Plumas County

Waterway	Bank	Unit Miles	Inspection Start/End	Inspector
Unit No. 01 North Fork Feather River	Left	1.89	04/22/2020 04/22/2020	Sterling York

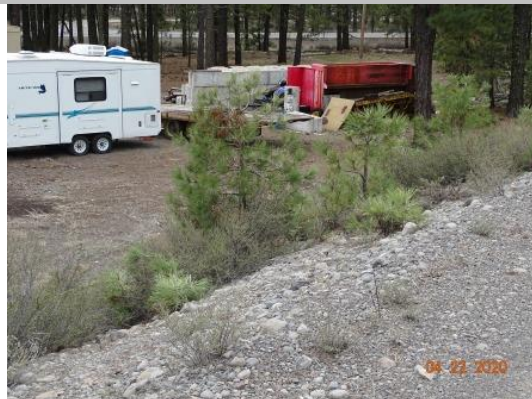
Photo 1 of 1 : SP_2020_NA0015_337_7_20200429_00007.jpg

LM Start	0.82	Rating **	M	Issue No.	7
LM End	0.82	Issue Type +	Ma	Location *	LS
Category	Earthen Levee			GPS Latitude/Longitude	
				Start	End
Item	Trim / Thin Trees			40.283462 °	40.283462 °
				-121.251156 °	-121.251156 °
DWR ID	DWR_NA0015_01_s_2020_7				
Comment Code					
T2 : Thin trees to allow visibility of the ground and room to flood fight.					
Inspector Comment					
Trees with less than 4" diameter at chest height should be removed, Spring 2020.

View looking downstream landside at small pine trees on the levee slope, Spring 2020.

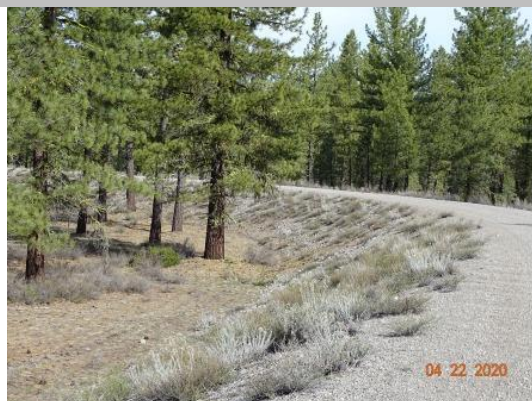
Photo 1 of 1 : SP_2020_NA0015_338_2_20200429_00009.jpg

LM Start	0.01	Rating **	A	Issue No.	2
LM End	1.33	Issue Type +	Ma	Location *	LS
Category	Earthen Levee			GPS Latitude/Longitude	
				Start	End
Item	Vegetation			40.286428 °	40.272110 °
				-121.259994 °	-121.247060 °
DWR ID	DWR_NA0015_02_s_2020_2				
Comment Code					
V1 : Control annual grass and weeds on the levee slopes and easements.					
Inspector Comment					
The annual vegetation is well maintained, Spring 2020.

View looking upstream landside at the well maintained annual vegetation, Spring 2020.

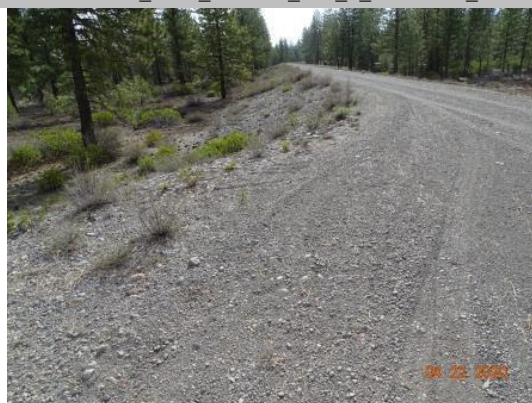
Photo 1 of 1 : SP_2020_NA0015_338_3_20200429_00008.jpg

LM Start	0.01	Rating **	A	Issue No.	3
LM End	1.33	Issue Type +	Ma	Location *	WS
Category	Earthen Levee			GPS Latitude/Longitude	
				Start	End
Item	Vegetation			40.286423 °	40.272110 °
				-121.259992 °	-121.247060 °
DWR ID	DWR_NA0015_02_s_2020_3				
Comment Code					
V1 : Control annual grass and weeds on the levee slopes and easements.					
Inspector Comment					
The annual vegetation is well maintained, Spring 2020.

View looking downstream waterside at the well maintained annual vegetation, Spring 2020.

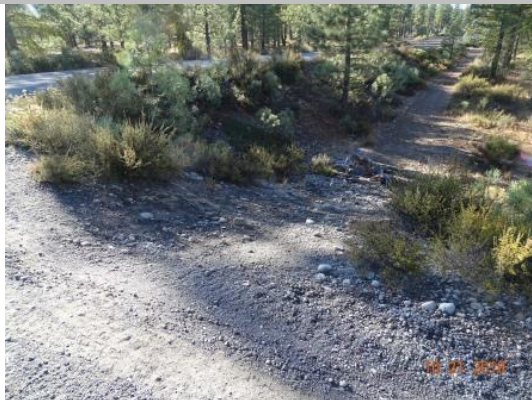
Photo 1 of 1 : SP_2020_NA0015_338_4_20200227_00001.jpg

LM Start	0.55	Rating **	A/W	Issue No.	4
LM End	0.55	Issue Type +	Ma	Location *	LS
Category	Earthen Levee			GPS Latitude/Longitude	
				Start	End
Item	Slope Stability			40.281950 °	40.281950 °
				-121.253710 °	-121.253710 °
DWR ID	DWR_NA0015_02_s_2012_4				
Comment Code					
S3 : Repair the levee slope damaged by vehicle traffic and prevent access where possible.					
Inspector Comment					
There is no sign of slope instability but should be monitored for the next year. The access has been blocked.

View of the undesignated vehicle access along the landside slope, there is no sign of slope instability but should be monitored.

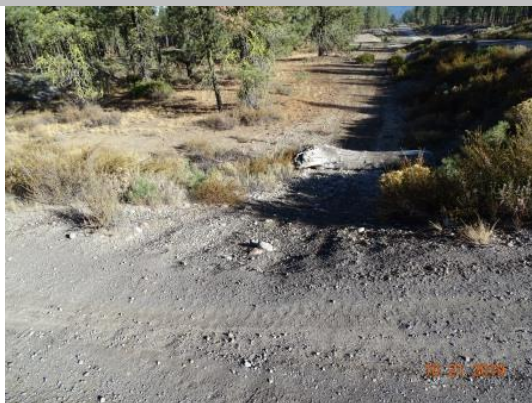
Photo 1 of 1 : SP_2020_NA0015_338_5_20200227_00002.jpg

LM Start	0.55	Rating **	A/W	Issue No.	5
LM End	0.55	Issue Type +	Ma	Location *	WS
Category	Earthen Levee			GPS Latitude/Longitude	
				Start	End
Item	Slope Stability			40.281950 °	40.281950 °
				-121.253710 °	-121.253710 °
DWR ID	DWR_NA0015_02_s_2012_5				
Comment Code					
S3 : Repair the levee slope damaged by vehicle traffic and prevent access where possible.					
Inspector Comment					
There is no sign of slope instability but should be monitored for the next year. The access has been blocked.

View of the undesignated vehicle access along the waterside slope, there is no sign of slope instability but should be monitored.

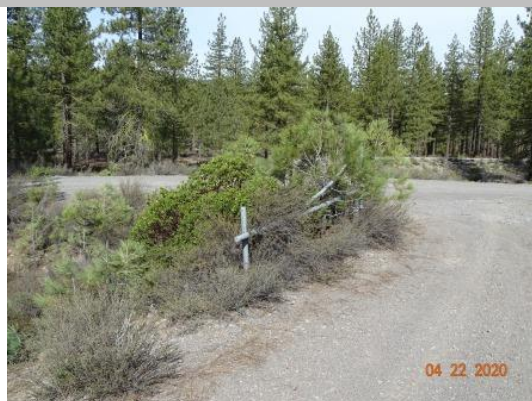
Photo 1 of 1 : SP_2020_NA0015_338_6_20200429_00010.jpg

LM Start	0.56	Rating **	M	Issue No.	6
LM End	0.56	Issue Type +	Ma	Location *	LS
Category	Earthen Levee			GPS Latitude/Longitude	
				Start	End
Item	Trim / Thin Trees			40.281897 °	40.281897 °
				-121.253372 °	-121.253372 °
DWR ID	DWR_NA0015_02_s_2020_6				
Comment Code					
T2 : Thin trees to allow visibility of the ground and room to flood fight.					
Inspector Comment					
Trees with less than 4" diameter at chest height should be removed, Spring 2020.

View looking upstream landside at small pine trees on the levee slope, Spring 2020.
